Chapter 5

REFINEMENT OF ALTERNATIVES

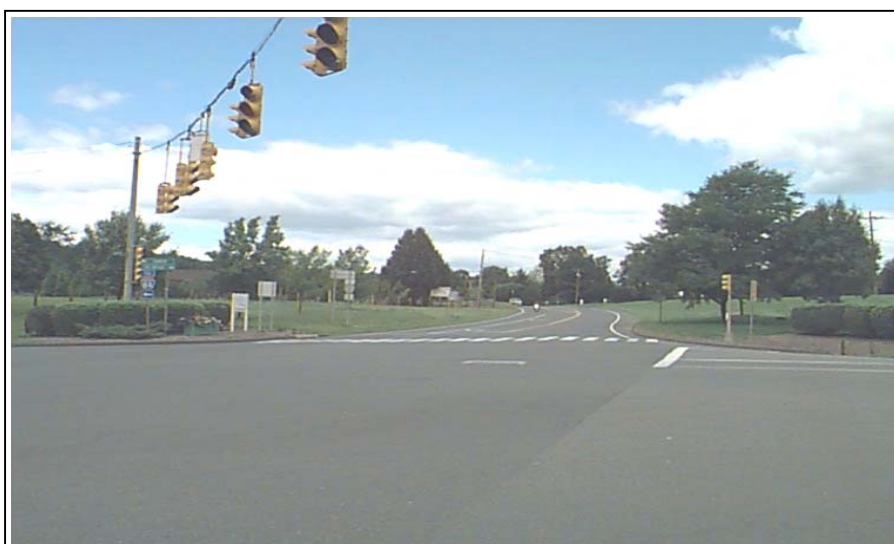
Figure 5.4

View of westbound approach on Main Street South at South Britain Road intersection

Constraints at the intersection of South Main Street and South Britain Road include a gas line that runs south of the intersection and parallel to Main Street South. There is also a commuter parking lot in the southeast quadrant of the intersection. In the northwest quadrant of the intersection, there are residential properties that should be considered prior to widening the intersection. This intersection is photographed in Figure 5.4.

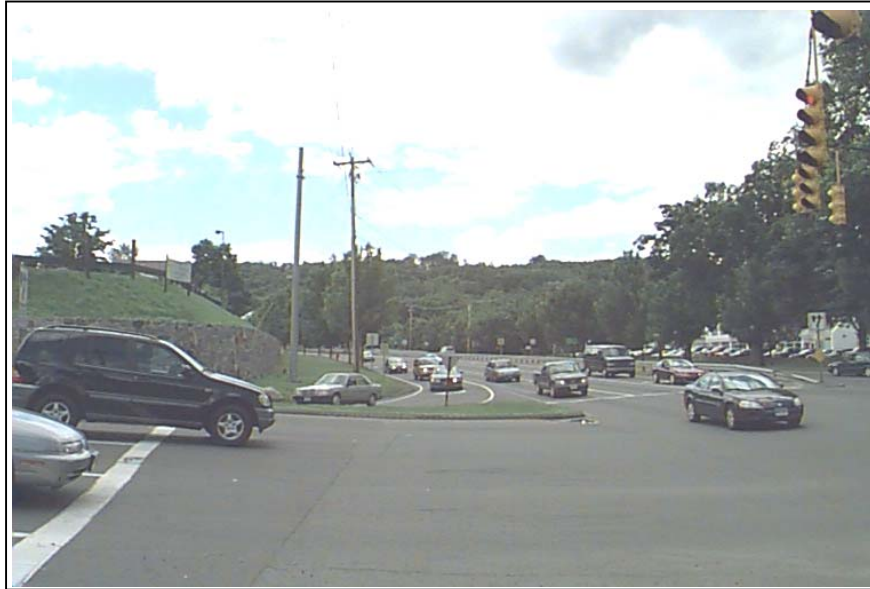
Figure 5.6

View of the northbound approach on Main Street at the Main Street/Route 6/Southbury Plaza intersection

lane on Route 6/67 would be shifted east of its present location due to the additional left turn lane. Based on field observations, it appears feasible to provide the additional widening on the east side without impacting the parking lot in Southbury Plaza. The improvements at this intersection are illustrated in [Figure 5.5](#). The existing intersection is photographed in Figures 5.6 and 5.7.

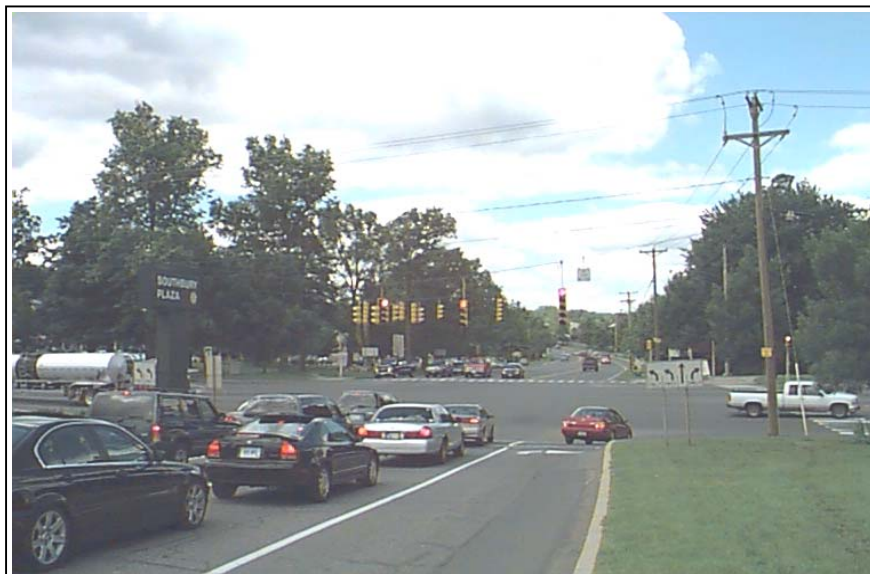
Figure 5.7

View of the Southbury Plaza driveway at the Main Street/Route 6/Southbury Plaza intersection

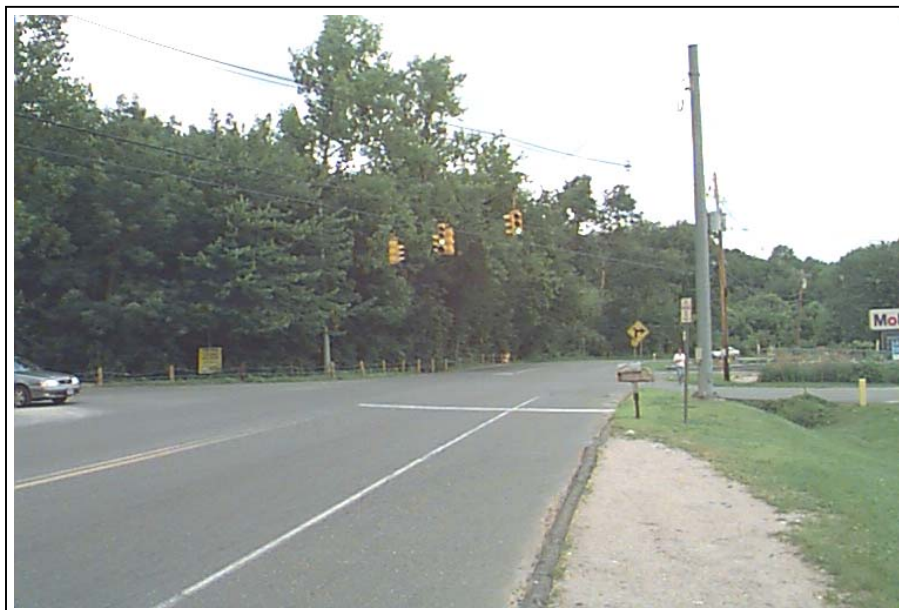
Figure 5.9

View of the Route 188 Northbound approach at the Route 188/Old Waterbury Road intersection

As a short-term solution, the two intersections should be widened as TSM improvements. In addition to the widening, the two signals should be coordinated to reduce queuing between intersections. Based on field observations, widening along Route 188 seems achievable east of the intersection due to the existence of wetlands west of the present alignment. The existing intersection is photographed in Figure 5.9.

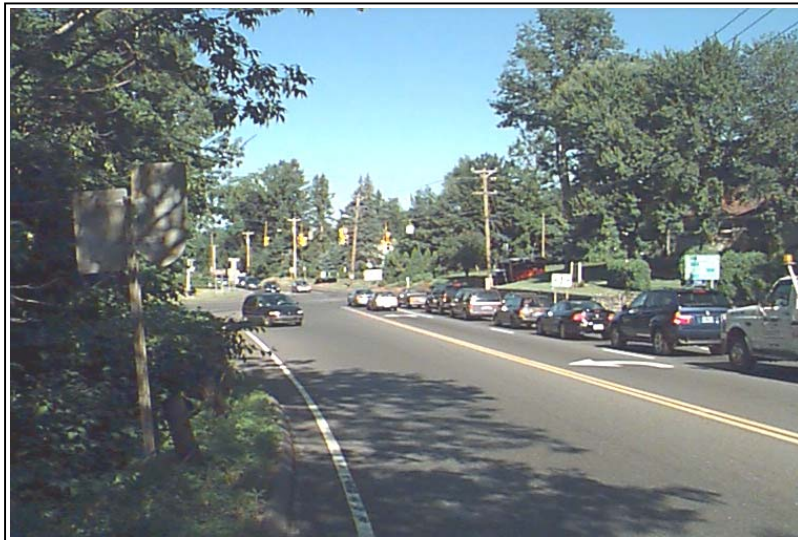
Figure 5.11

View of the westbound approach on Route 64 at Route 63 and Route 64 intersection

interchange are listed in Table 5.6. The improvements proposed at this intersection are illustrated in [Figure 5.10](#). The existing intersection is photographed in Figures 5.11 and 5.12.

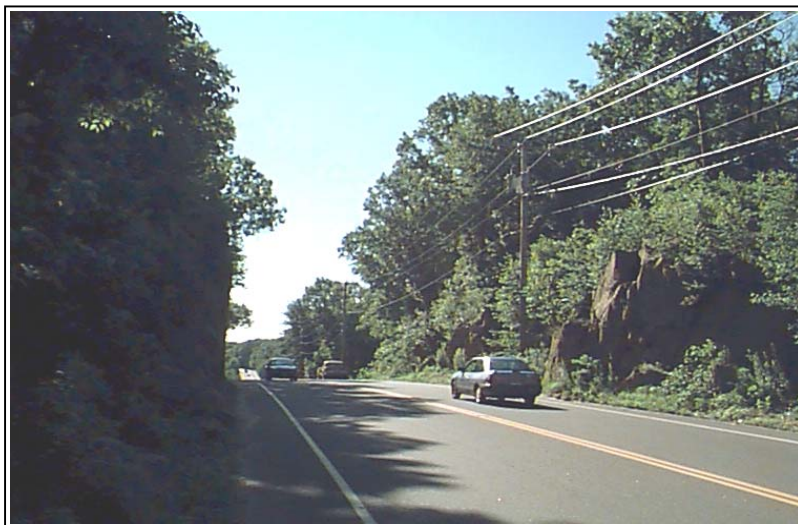
Figure 5.12

View of Route 64 with limited sight distance and rock ledge on both sides of the roadway

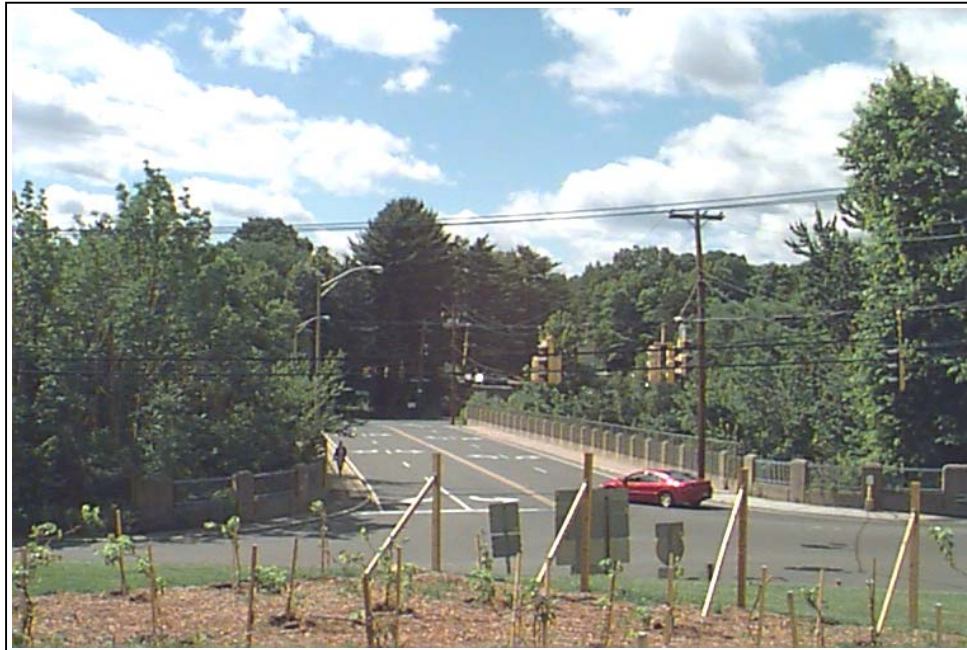
Figure 5.14

View of the Chase Parkway bridge over I-84

Other improvements at this interchange are related to highway and roadway signage and may be pursued as short-term improvements. The existing intersections are photographed in [Figures 5.14 and 5.15](#).

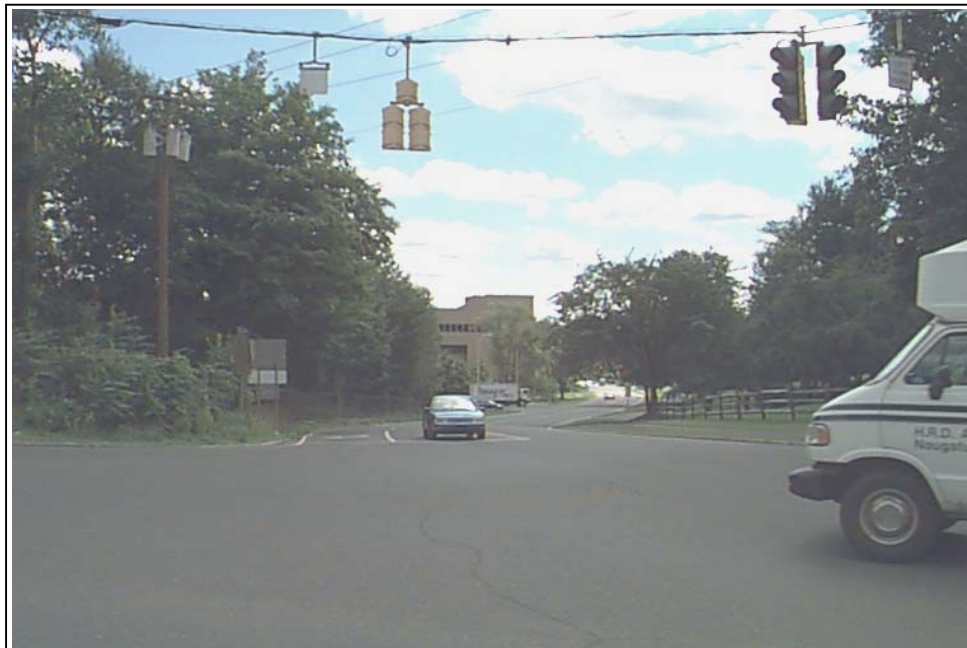
Figure 5.15

View of the Chase Parkway EB approach at Country Club Road and Chase Parkway intersection
